DTE Energy Monroe Power Plant

Inactive Bottom Ash Impoundment CCR Rule Compliance Project

Annual Inspection Report - 2019

Project Number: 60516675

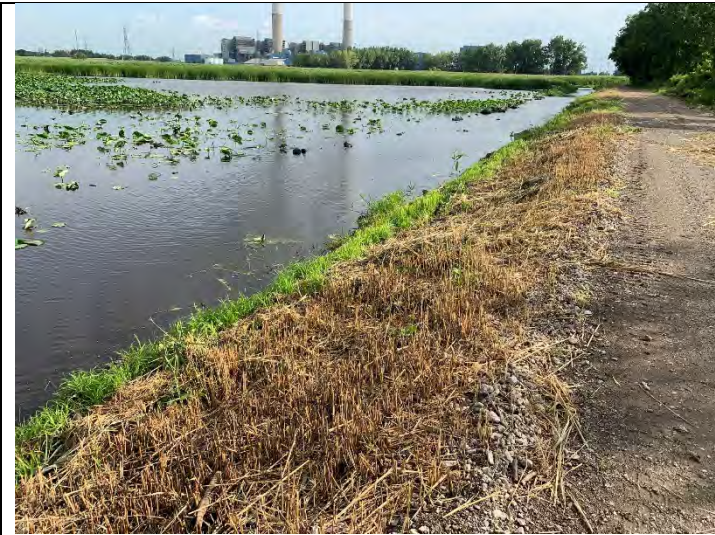
Photo 1: Looking north along east access road

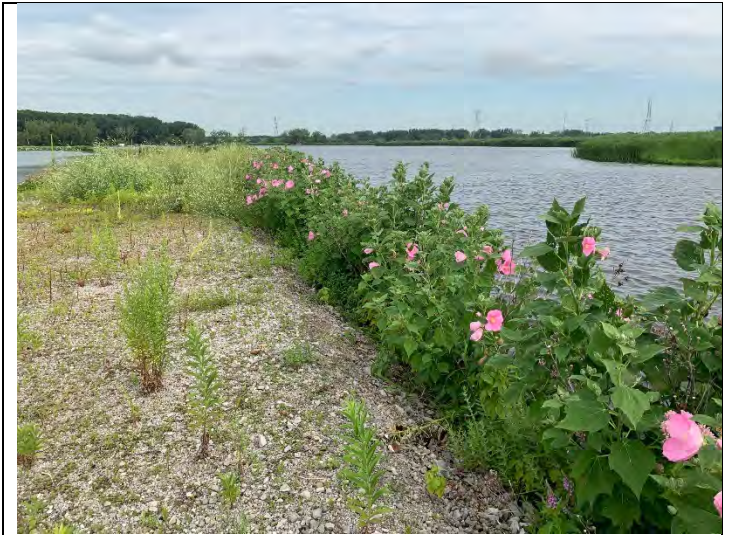
Photo 2: Looking west from east access road at south separation berm.

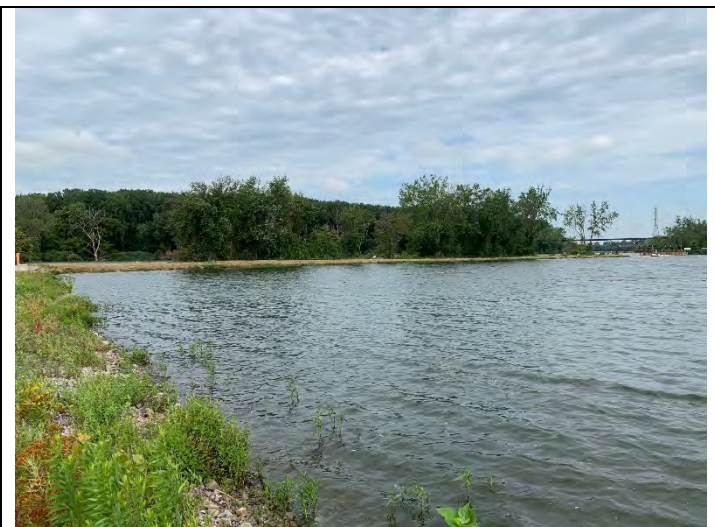
Photo 3: Looking west south separation berm to western edge of impoundment.

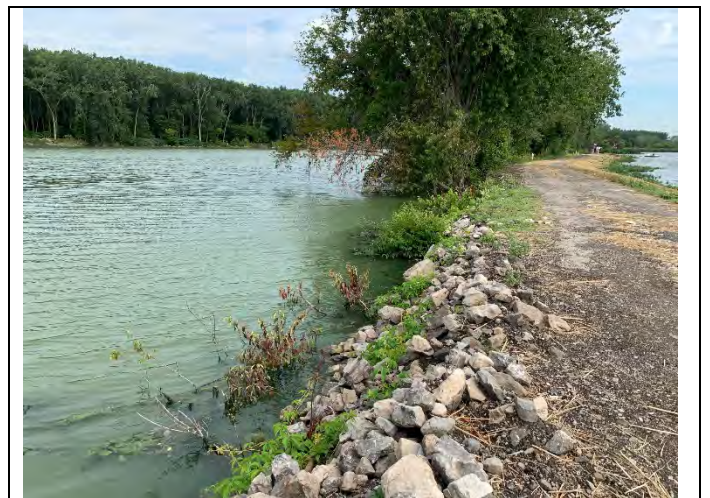
Photo 4: Area along the west berm repaired with additional rip-rap since 2018 inspection

DTE installed additional rip-rap along the western slope of the impoundment to repair areas where rip-rap has sloughed down the slope.

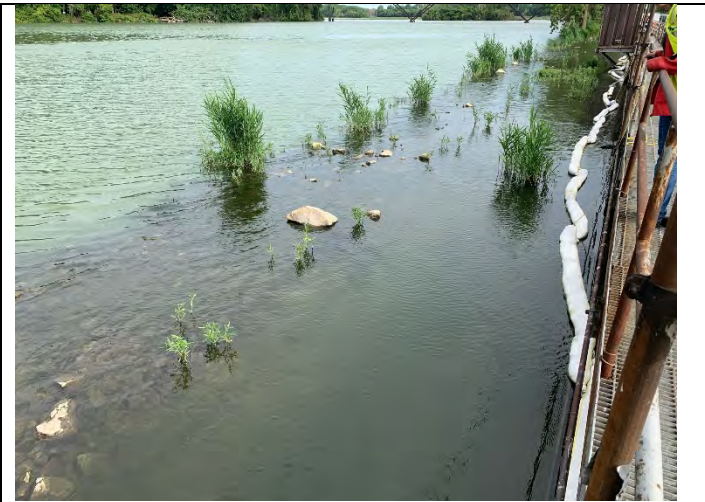
Photo 5: Looking northwest from the walkway of the weir – water levels in the discharge canal are significantly higher than previous years
